Picacho Hills Drive/ Barcelona Ridge Road Corridor Safety Assessment (CSA)

Final Report

Revision 1

April 2020

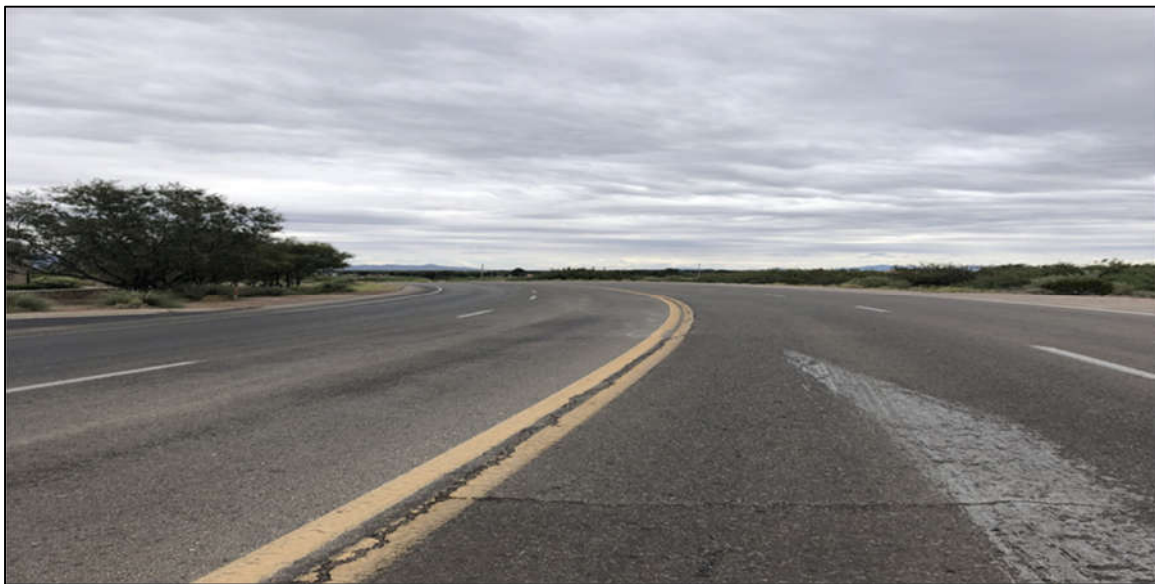
Figure 3. Horizontal Curve along Picacho Hills Drive

- Currently, the road is signed for 35 mph in both directions near the study intersections, with a 30 mph advisory speed posted near some of the horizontal curves in the business area.

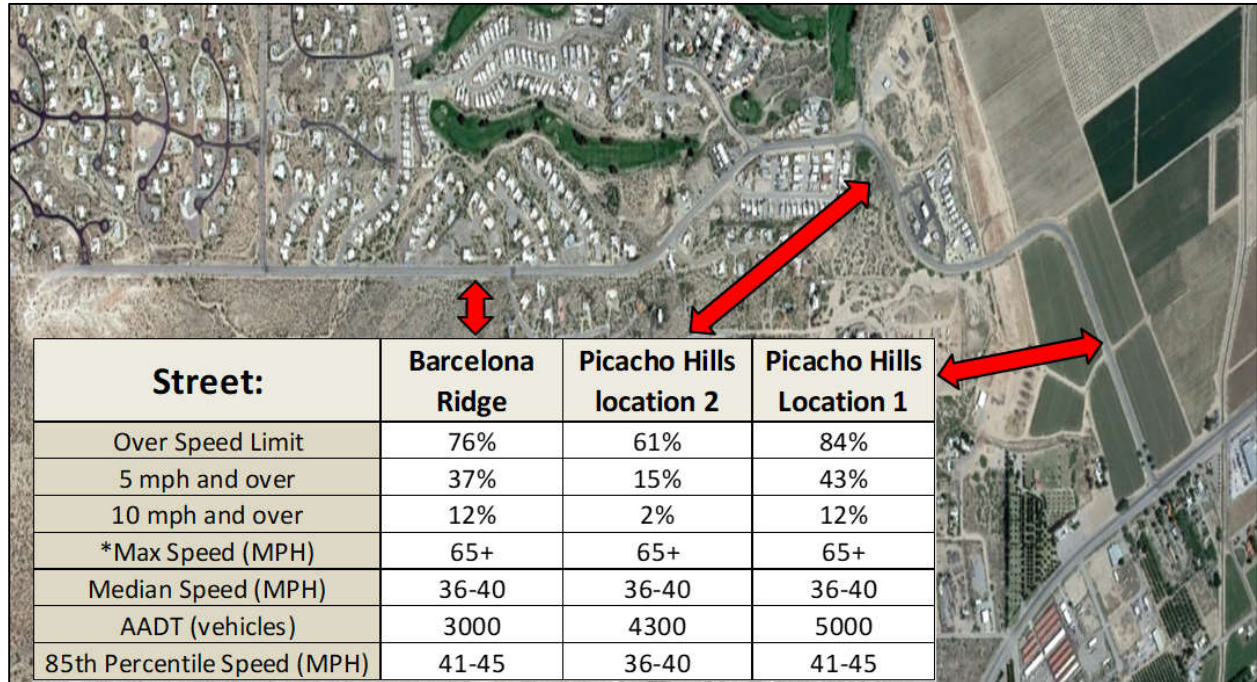
Figure 10. 2018-2019 Speed Data and Volumes

- The 85th Percentile speed for traffic at location 1 on Picacho Hills was observed to be in the range between 41-45 mph, which is greater than the posted speed limit of 35 mph within the data collection area. 84% of observed vehicles were driving over the posted speed limit.

- The 85th Percentile speed for traffic at location 2 on Picacho Hills was observed to be in the range between 36-40 mph, which is greater than the posted speed limit of 35 mph within the data collection area. 61% of observed vehicles were driving over the posted speed limit.
- The 85th Percentile speed for traffic on Barcelona Ridge was observed to be in the range between 41-45 mph, which is greater than the posted speed of 35 mph within the data collection area. 76% of observed vehicles were driving over the posted speed limit.

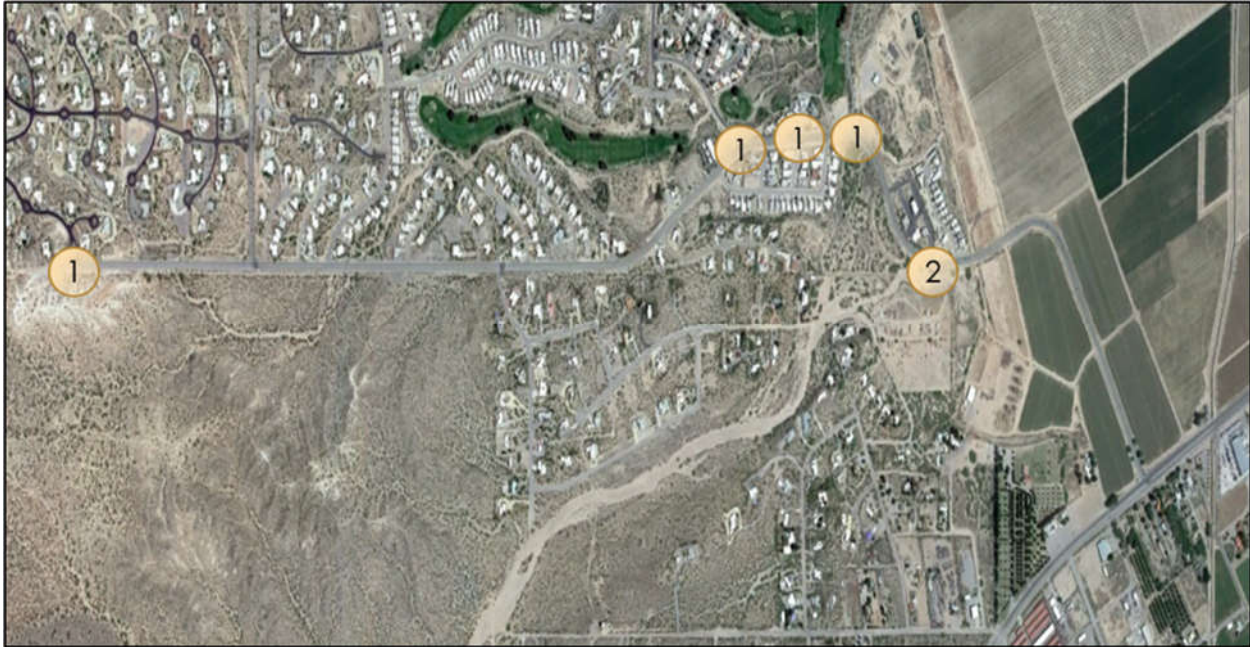
Figure 13. Vehicle Crash Locations form 2016-2018

- Based on the data available, no fatal crashes occurred in this corridor.
- 67% (4 crashes) of the total crashes occurred during daylight, with 33% (2 crashes) occurring during night time.
- 17% (1 crashes) of the total crashes were reported as injuries with 67% (4 crashes) of the total crashes reported as property damage only.
- Based on the small number of accidents in this study area, we were unable to determine a trend in the cause of the crashes that were reported.

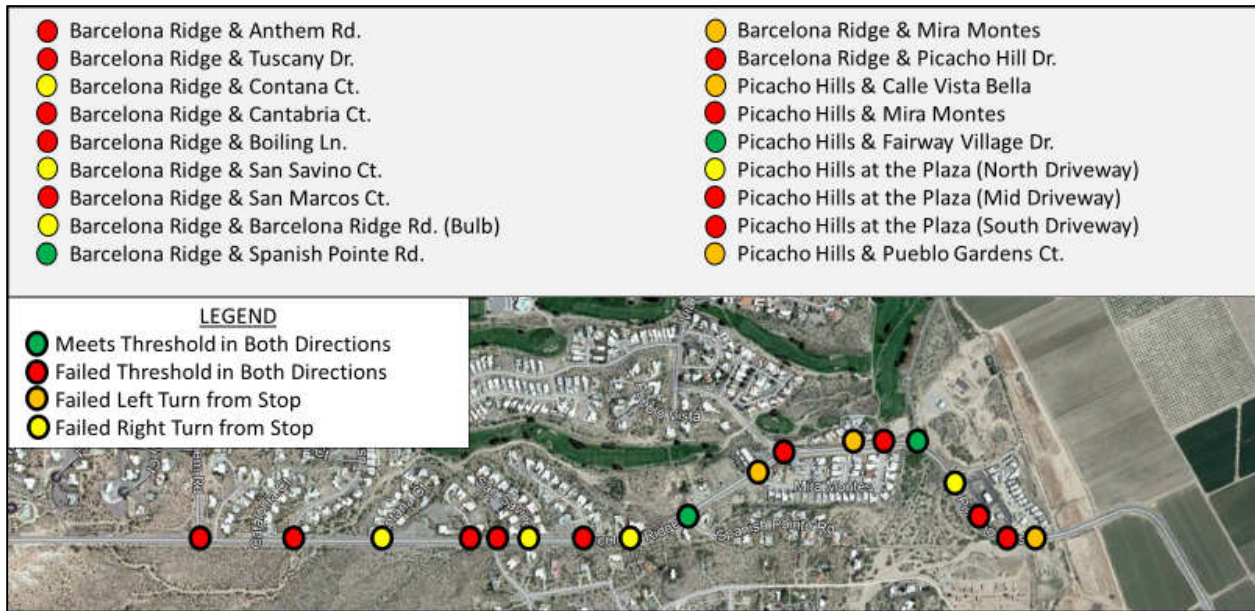
Figure 16. Location of Failing Intersection Sight Distances for current conditions

Table 8 shows the results based on current conditions from each intersection, along with observed safety issues from the field visit. **Table 9** shows the results of the 85th Percentile max value (MPH). Highlighted are the movements from the minor road onto the major road that failed to meet the desired threshold requirements. **Table 8** indicates that only two intersections meet the required Intersection Sight Distances in both directions of travel. Those two intersections are located at Barcelona Ridge & Spanish Pointe Rd. and Picacho Hills & Fairway Village Dr. **Table 9** only has one intersection that meets the threshold in both directions due to the higher rate of speeds. That intersection is at Picacho Hills & Fairway Village Dr. **Figure 16** and **Figure 17** illustrate the locations of the failing intersections.

Barcelona Ridge & Spanish Pointe Rd.	518	600	Obstructions caused by horizontal curves in both directions
Barcelona Ridge & Mira Montes	280	700	Landscape rock wall obstruction and horizontal curves
Barcelona Ridge & Picacho Hills	313	140	Landscape median obstruction in both directions, horizontal and verticle curves
Picacho Hills & Calle Vista Bella	330	1000	Obstructions caused by vertical and horizontal curves
Picacho Hills & Mira Montes	271	423	Landscape rockwall obsruction, horizontal and vertical curves
Picacho Hills & Fairway Village Dr.	700	700	Obstructions caused by moderate vegetation overgrowth
Picacho Hills at The Plaza (North Driveway)	700	327	Landscape obstructions and advertisement billboard
Picacho Hills at The Plaza (Mid Driveway)	367	177	Landscape obstructions in both directions and horizontal curves
Picacho Hills at The Plaza (South Driveway)	267	175	Landscape wall obstructions, vegetation overgrowth, and horizontal curves

- Driveway Restrictions at the business area
 - Cost estimation - \$1,000-\$2,000
- Remove and reduce vegetation/landscaping obstructions
 - Cost estimation - \$5,000-7,000
- Warning Flashers near the business area
 - Cost estimation - \$30,000
- Road Diet in the business area
 - Cost estimation - \$50,000
- Roadway Re-Configuration from 4-lane to 3-lane TWTL (Road Diet) (traffic is pulled away from the edge of the traveled lane)
 - Cost estimation - \$440,000
- Roadway Re-Configuration (Decrease lane widths and stripe or increase existing bike lane)
 - Cost estimation - \$440,000

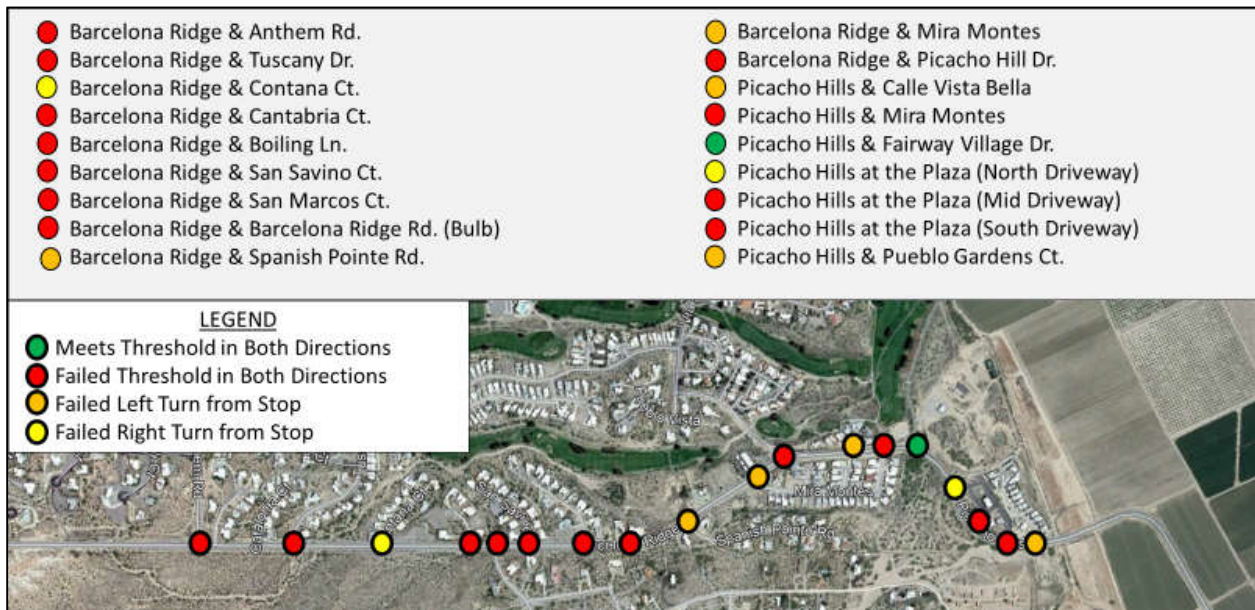
Figure 17. Location of Intersection Sight Distances for 85th Percentile conditions

Barcelona Ridge & Spanish Pointe Rd.	518	600	Obstructions caused by horizontal curves in both directions
Barcelona Ridge & Mira Montes	280	700	Landscape rock wall obstruction and horizontal curves
Barcelona Ridge & Picacho Hills	313	140	Landscape median obstruction in both directions, horizontal and vertical curves
Picacho Hills & Calle Vista Bella	330	1000	Obstructions caused by vertical and horizontal curves
Picacho Hills & Mira Montes	271	423	Landscape rockwall obstruction, horizontal and vertical curves
Picacho Hills & Fairway Village Dr.	700	700	Obstructions caused by moderate vegetation overgrowth
Picacho Hills at The Plaza (North Driveway)	700	327	Landscape obstructions and advertisement billboard
Picacho Hills at The Plaza (Mid Driveway)	367	177	Landscape obstructions in both directions and horizontal curves
Picacho Hills at The Plaza (South Driveway)	267	175	Landscape wall obstructions, vegetation overgrowth, and horizontal curves

Picacho Hills at Pueblo Gardens Ct.	375	2000	Landscape obstructions and horizontal curves

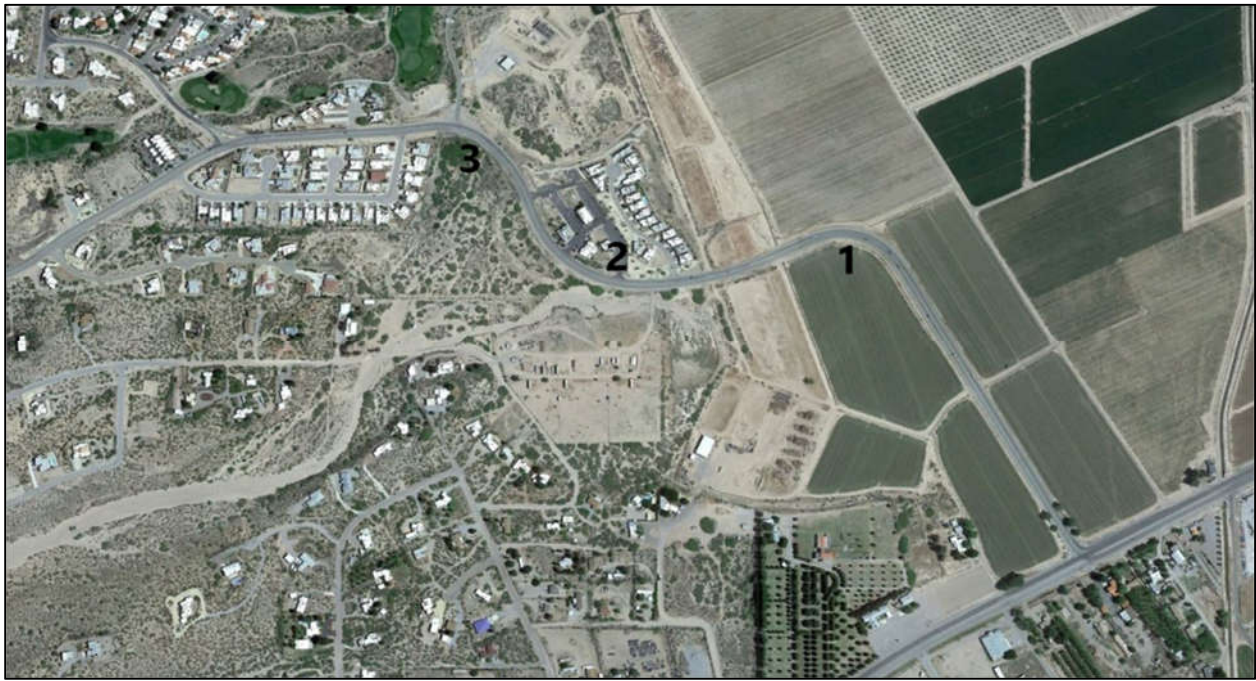
Figure 18. Ball Bank Study Locations of Horizontal Curves

evaluate the horizontal curve locations along the Picacho Hills corridor are illustrated in **Figure 18**. Advisory speeds around these horizontal curves are currently signed for an auxiliary speed of 30 MPH. Three trial runs in both directions were conducted at three different speeds (+/-30MPH) of 25, 30, and 35 MPH to determine if current conditions meet the MUTCD threshold. A summarization of the BBI results can be review in **Table 10**. Highlighted in red are attempts that failed to meet proper MUTCD criteria. Results show that existing advisory speed is properly signed for an advisory speed of 30 MPH. MUTCD criteria for Advisory Speeds can be viewed in **Appendix E**.
